SOUTHWEST RESEARCH INST SAN ANTONIO TEX
DEVELOPMENT OF DIAGNOSTIC TEST EQUIPMENT FOR INSPECTING ANTIFRI--ETC(U)
MAR 77 F N KUSENBERGER, J R BARTON

March 1977

4. TITLE (and Subtitle) DEVELOPMENT OF DIAGNOSTIC TEST EQUIPMENT FOR INSPECTING ANTI- FRICTION BEARINGS ✓		5. TYPE OF REPORT & PERIOD COVERED Final Report, Sept. 19, 1973 to Feb. 28, 1977 ✓

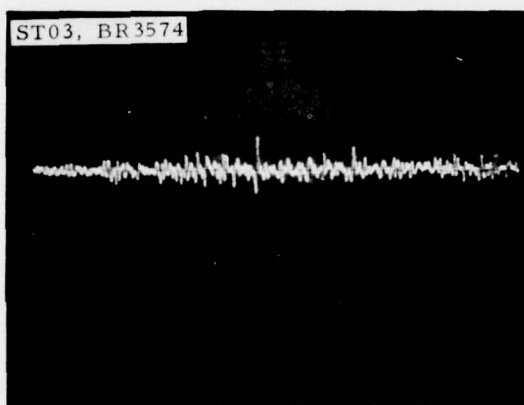
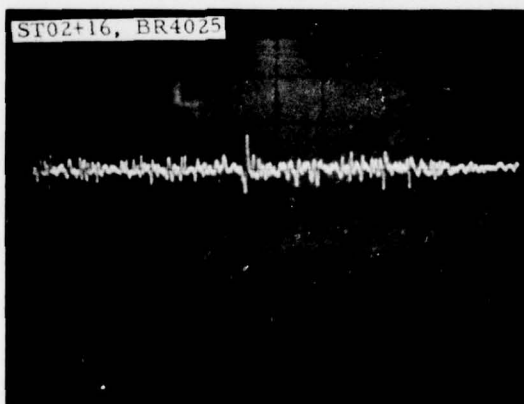
FIGURE 21. CIRCUMFERENTIAL MAGNETIC PERTURBATION SIGNATURES
FROM THREE LOCATIONS ON P/N 1-300-015, S/N 470V(2)
INNER RACE (HALF)

Figure 24 shows surface photographs of the raceway surface of the three regions corresponding to the signatures previously presented in Figures 21 and 22. The reticle in each of the photographs of Figure 24 indicates the projected flaw locations; no significant surface indications are present. A small subsurface inclusion, approximately 0.0006 inch (0.015 mm) in diameter and approximately 0.002 inches (0.050 mm) beneath the surface was found to correlate with the signature at Location A (see Figures 21 and 22) as illustrated in Figure 25. No significant flaws were found corresponding with locations B and C (reference Figures 21 and 22). It is informative to re-examine the signatures at locations A, B and C in Figure 22 in terms of the details of signature characteristics. The location A signature had good symmetry and shape with a peak separation of approximately 0.0036 inch (0.09 mm) and extended over about one scan track width 0.02 inches (0.50 mm). Location B and C signatures extended at least two scan track widths across the ball groove and the records in Figure 22 show both signatures to have poor symmetry (downward-going peak less in amplitude than upward-going peak); peak separations in the range of 0.0025 to 0.003 inch (0.063 to 0.075 mm). Also note that the location B and C signatures have a poor shape leading into the downward-going as indicated by the "a" in the records of Figure 22. Signatures such as B and C, if from an inclusion, would be anticipated to be associated only with a group ("cloud") of small [less than 0.0005 inch (0.012 mm) diameter], subsurface inclusions distributed across the ball groove. However, no such flaws

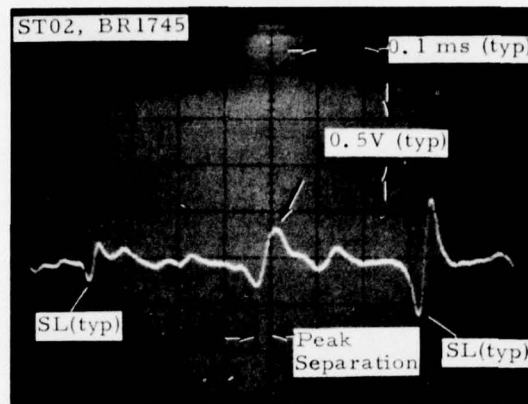
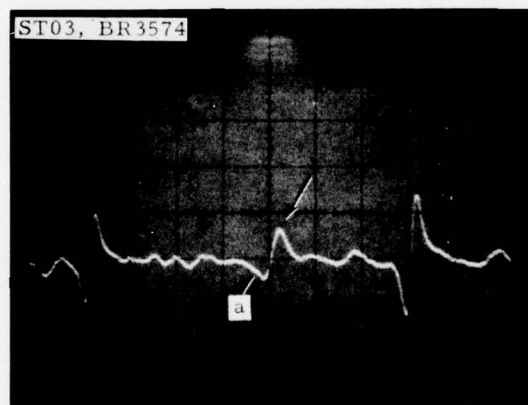
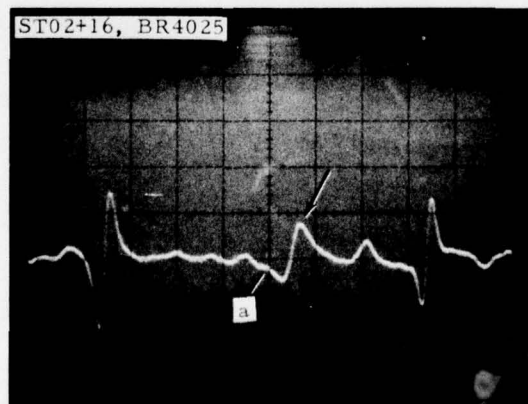
FIGURE 22. CIRCUMFERENTIAL SIGNATURES (with scribe line signals expanded) FROM THREE LOCATIONS ON P/N 1-300-015, S/N 470V(2) INNER RACE (HALF)

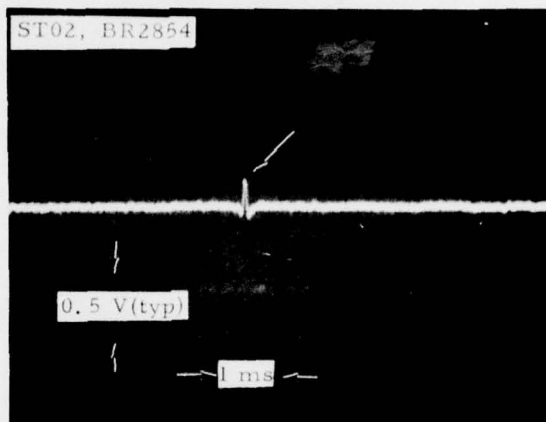
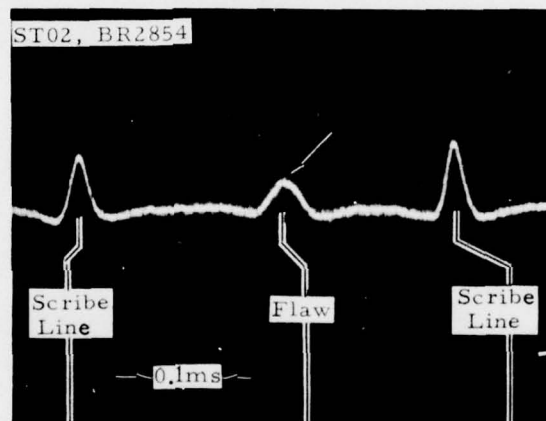
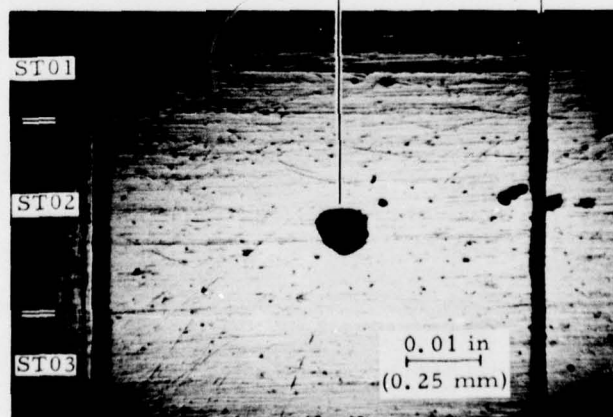
FIGURE 23. MAGNETIC PERTURBATION RADIAL SIGNATURES AND SURFACE PHOTOMICROGRAPH ILLUSTRATING METHOD FOR ACCURATELY DETERMINING FLAW SIGNATURE LOCATION ON RACE (P/N 1-300-015, S/N 455Z(2))

The upper record, Figure 23, shows the radial signature obtained prior to addition of the scribe lines; the center record shows signatures from the flaw and the scribe lines placed on either side; the lower surface photomicrograph shows both the scribe lines and the

flaw. In the case of these radial signatures, the location of the flaw with respect to the scribe lines was calculated assuming the peak of each of the radial signals corresponded to the centroid of the defect and that of each scribe line. The procedural test illustrated in Figure 23 resulted in a flaw location prediction within approximately 0.001 inch (0.025 mm) of the location physically measured on the surface of the specimen.

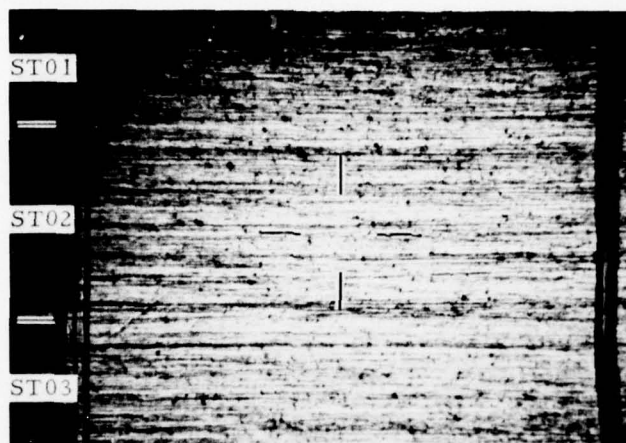
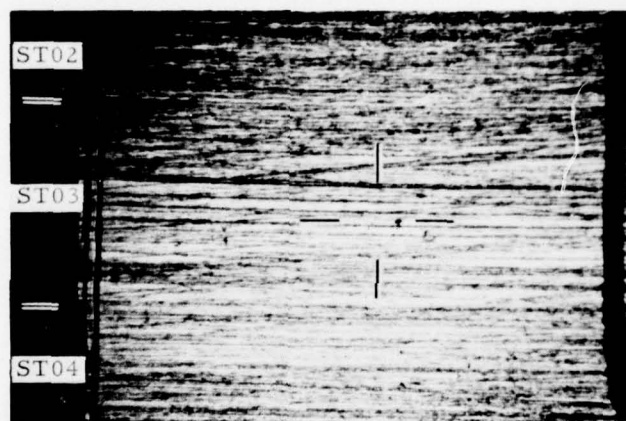
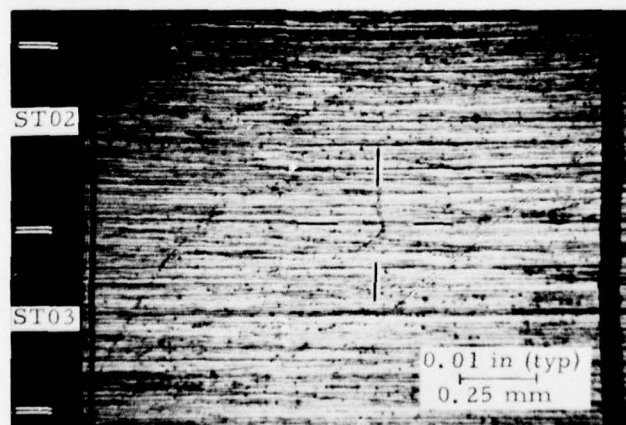
FIGURE 24. SURFACE PHOTOMICROGRAPHS OF REGIONS (Locations A, B, C) CORRESPONDING TO THREE SIGNATURES ON P/N 1-300-015, S/N 470V(2) INNER RACE (HALF)

were found in the region examined. Accordingly, it is suggested that the signatures B and C were caused by slight local metallurgical composition changes such as fiber flow; the signature extent (1.0 mm) across the race groove and the small amplitude are the primary factors supporting this suggestion. Also, while an inclusion was found to coincide with signature A, the inclusion approaches the lower limit which could possibly be resolved at this depth from the magnetic background signatures.

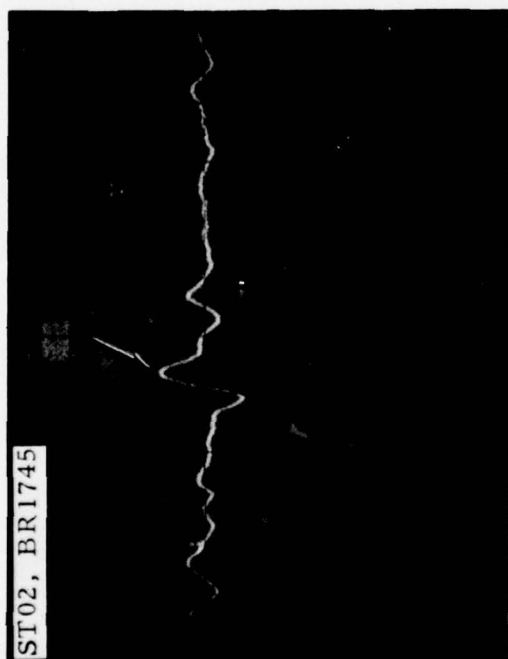
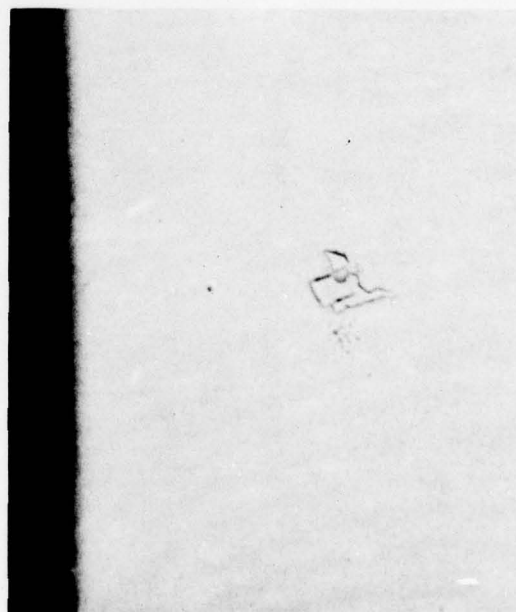
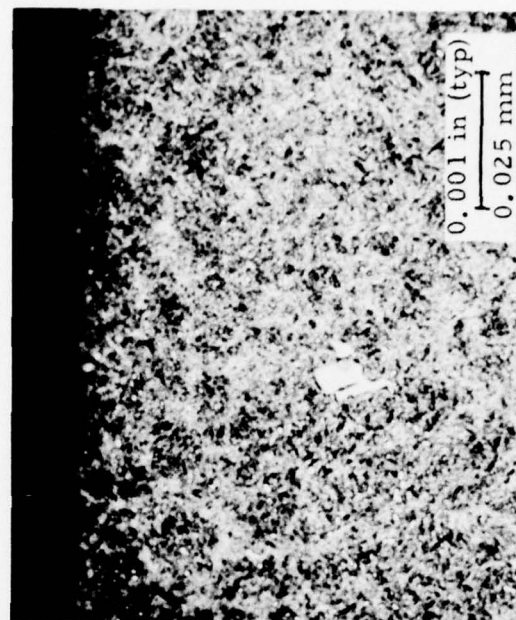
FIGURE 25. MAGNETIC PERTURBATION CIRCUMFERENTIAL SIGNATURE AND CORRESPONDING SUBSURFACE FLAW, P/N 1-300-015, S/N 470V(2) INNER RACE (HALF)

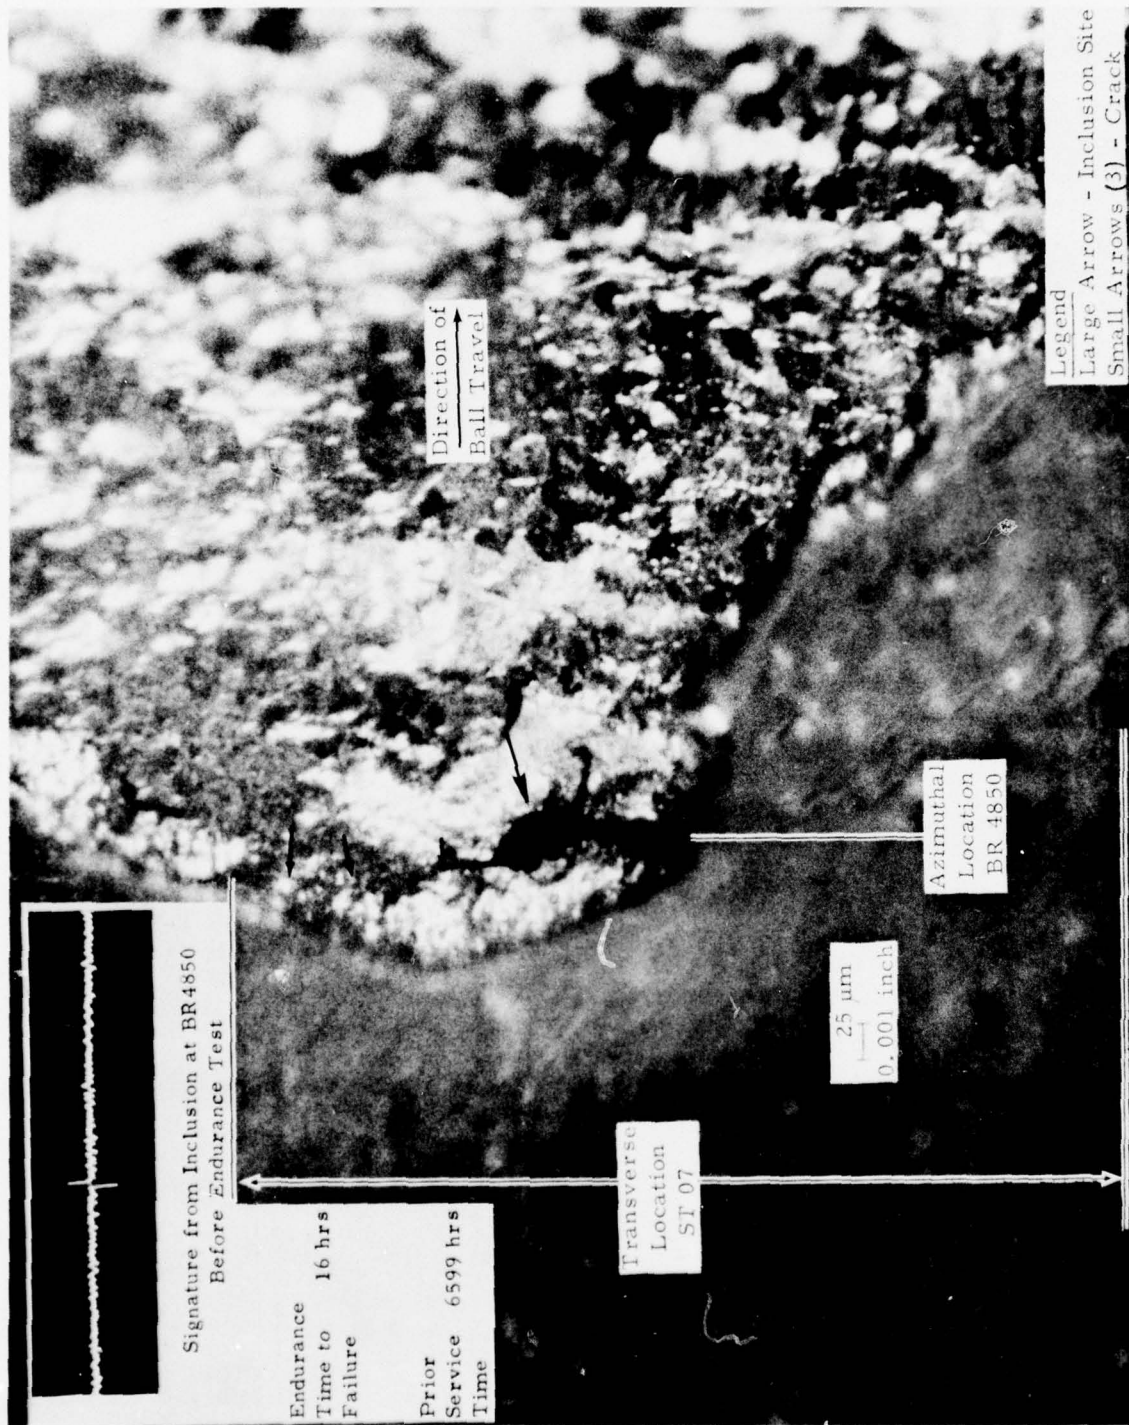
FIGURE 27. PHOTOGRAPH OF LEADING EDGE OF SPALL AND INSPECTION SIGNATURE OBTAINED PRIOR TO ENDURANCE TESTING

From subsequent comprehensive correlation analyses, it was determined that the spall initiated from a source corresponding to the precise location of an outstanding magnetic perturbation circumferential signal obtained prior to start of the endurance test. Furthermore, the specific signature was the basis for selecting the bearing for endurance testing from a large group screened to obtain candidate specimens. Figure 26 is a reproduction of the initial inspection printout. Note that no magnetic perturbation radial or laser light signals corresponding to the magnetic perturbation circumferential signal at BR 4850 was obtained; also there was no significant surface flaw present in this region prior to endurance testing. Figure 27 shows a surface photomicrograph of the leading edge of the spall as a result of testing and a reproduction of the circumferential inspection record obtained prior to testing in the region of the BR 4850 printout; note the outstanding signal present in the inspection record. The peak separation of the signature, obtained prior to endurance testing, was 0.0025-inch (0.063 mm) indicating the presence of an inclusion whose center was approximately 0.001-0.002 inch (0.025-0.050 mm) beneath the raceway surface. In the photomicrograph of the leading edge of the spall, the site of the inclusion corresponding to the BR 4850 location is pointed out by the arrow (the small arrows point out a crack). These endurance test results clearly establish the critical role that such small nonmetallic flaws can play in the service life of expensive and critical bearing components. Furthermore, the initiation of failure at the precise location predicted by the magnetic perturbation signature prior to endurance testing establishes the capability of these inspection methods to detect critical flaws in bearings -

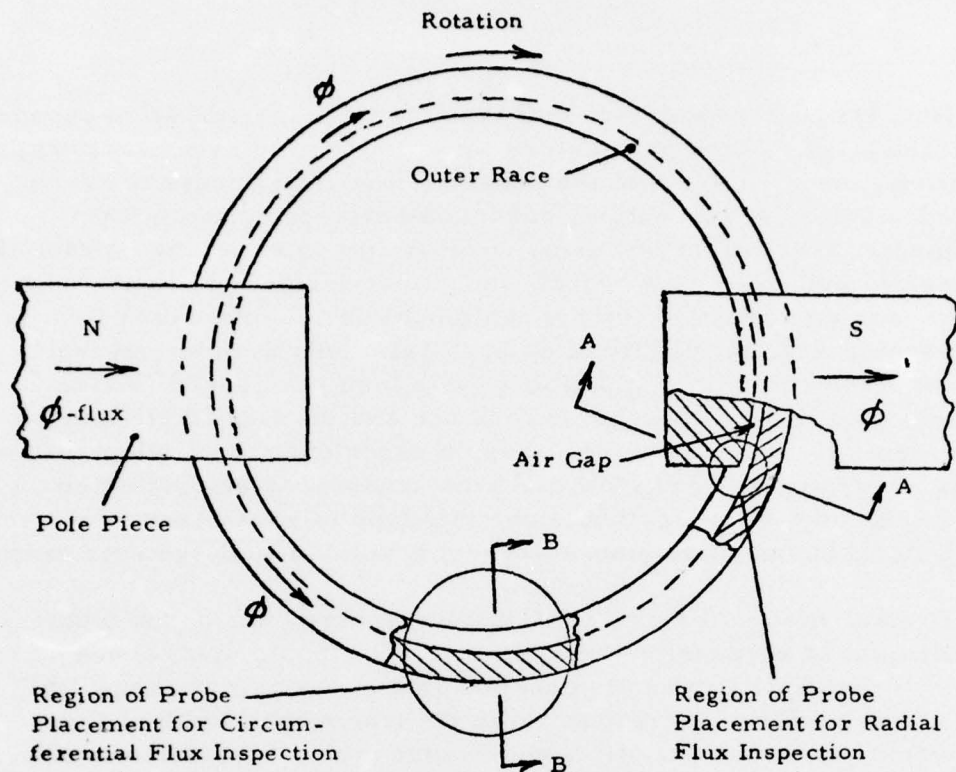
Note: Loading and unloading of the ring is accomplished by moving pole pieces toward each other to clear raceway, lowering ring below pole pieces, then moving pole pieces apart to clear O. D. of the ring.

FIGURE A1. MAGNETIZATION AND PROBE CONFIGURATION FOR OUTER RING

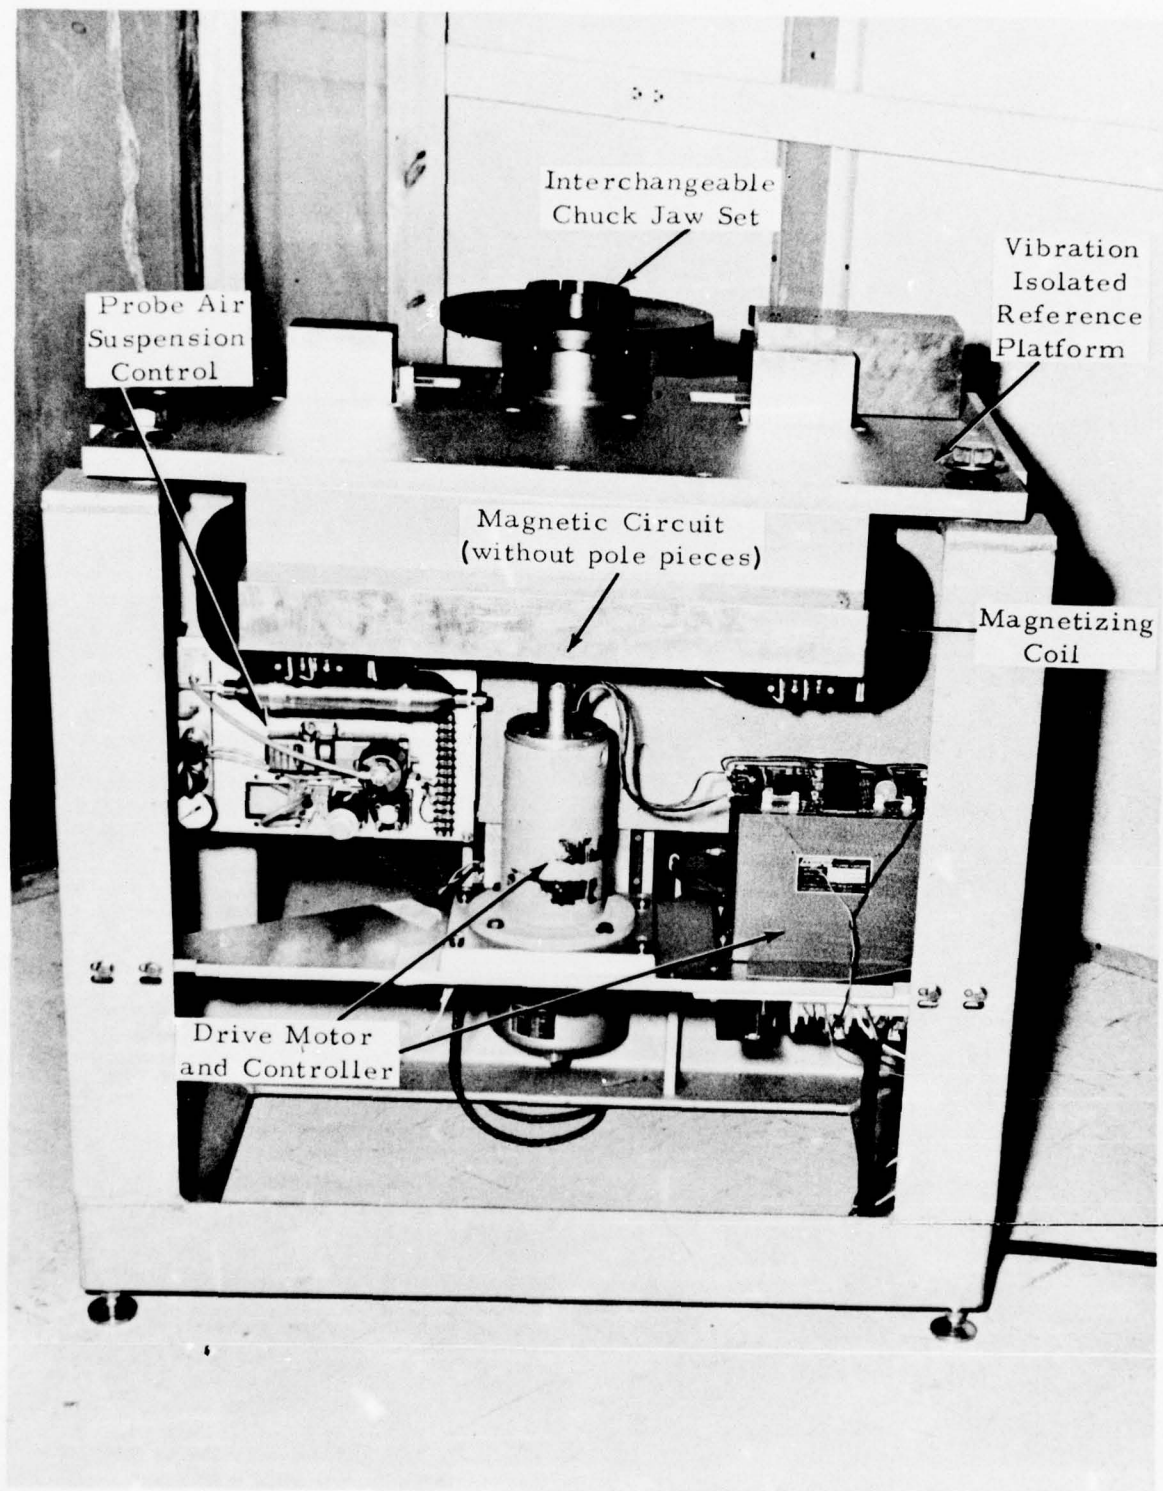
FIGURE A2. REAR VIEW OF BEARING INSPECTION DEVICE ROTATING AND MAGNETIZING SUBASSEMBLY (Preliminary Prototype)

Figures A2 and A3 show views of the preliminary prototype inspection head during development. Several of the more significant

items in the assembly are pointed out in these figures. In the delivered prototype (CCAD) system, a commercial spindle was used for rotation of the bearing; however, because of a 26-week delivery quotation, a spindle was designed and fabricated for the preliminary prototype. The design of the fabricated spindle was made similar to the commercial item such that it is possible to directly replace it with a commercial unit.

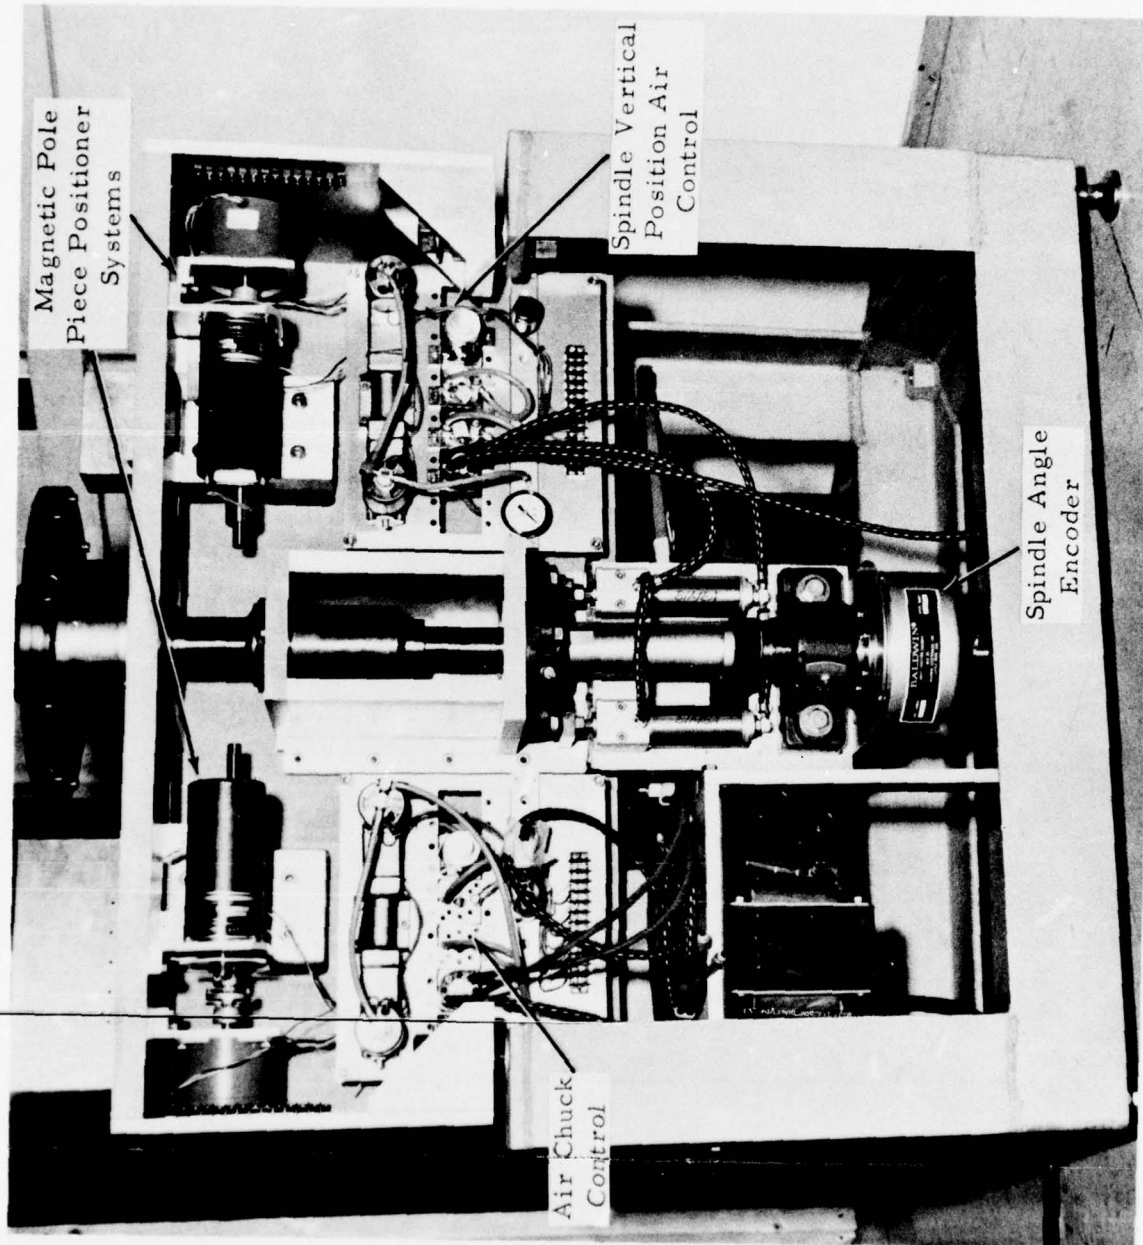
FIGURE A3. FRONT VIEW OF BEARING INSPECTION DEVICE ROTATING AND MAGNETIZING ASSEMBLY (Preliminary Prototype)

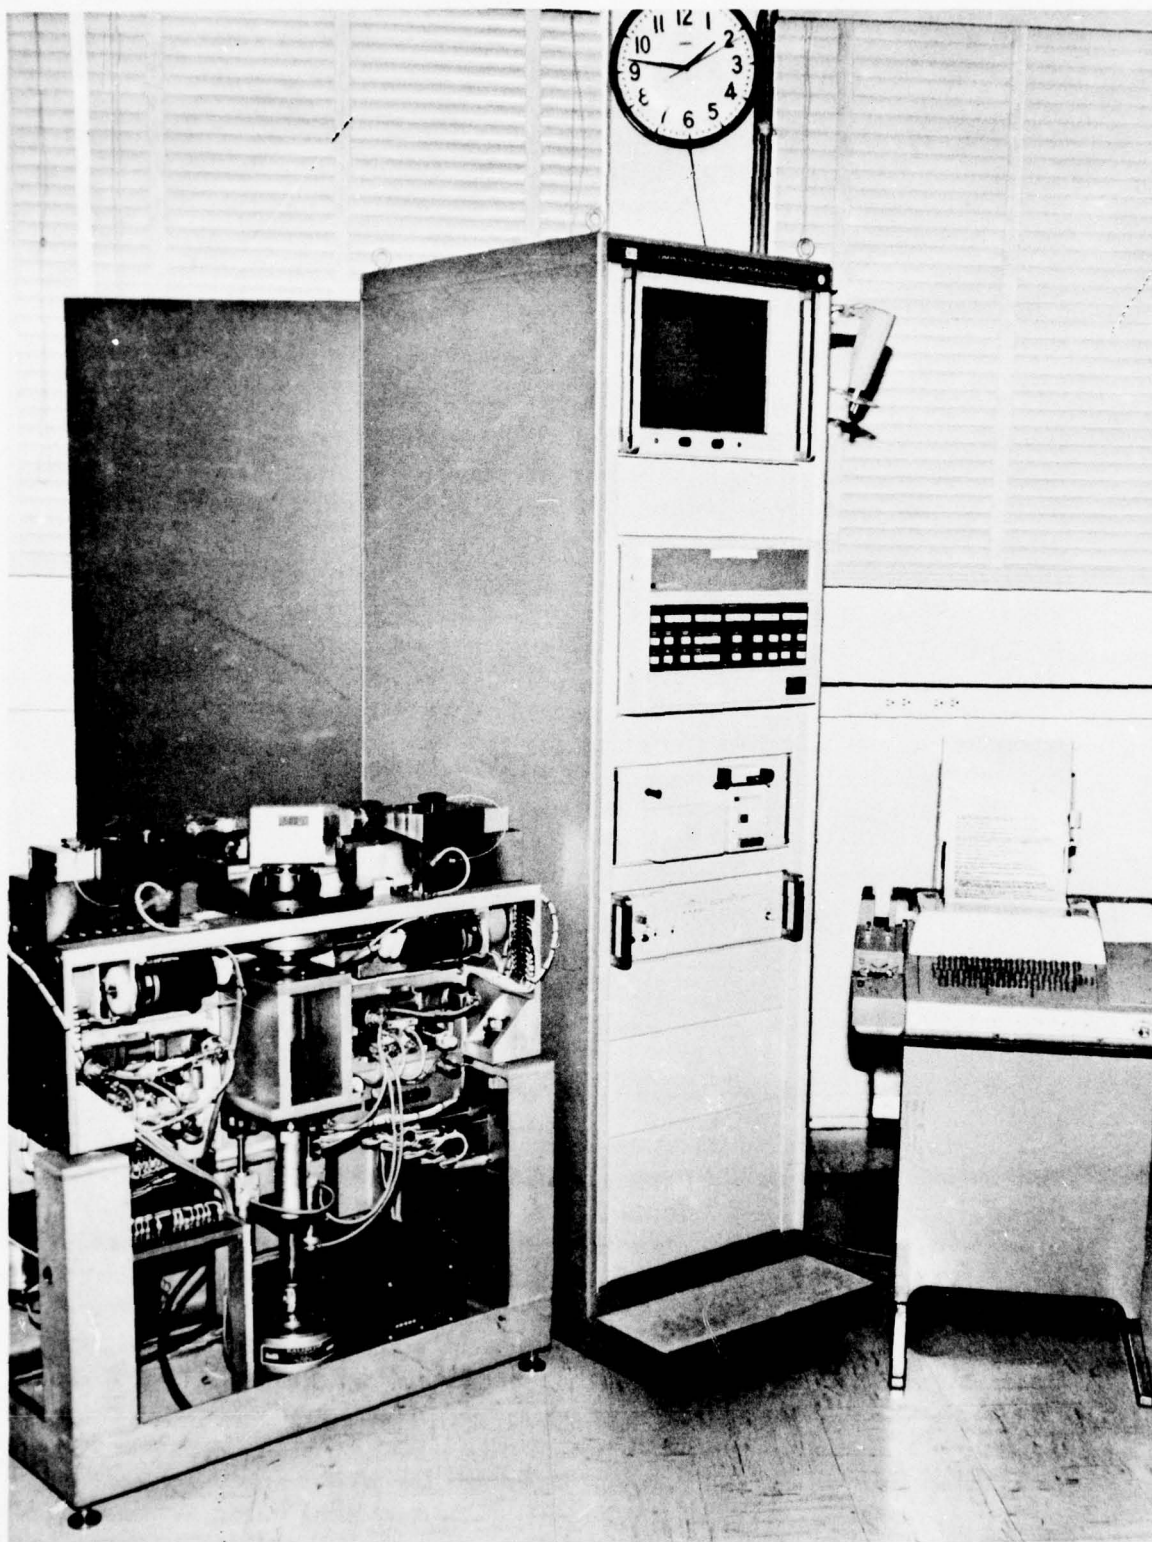
FIGURE A4. OVERALL VIEW OF PRELIMINARY PROTOTYPE BEARING INSPECTION UNIT

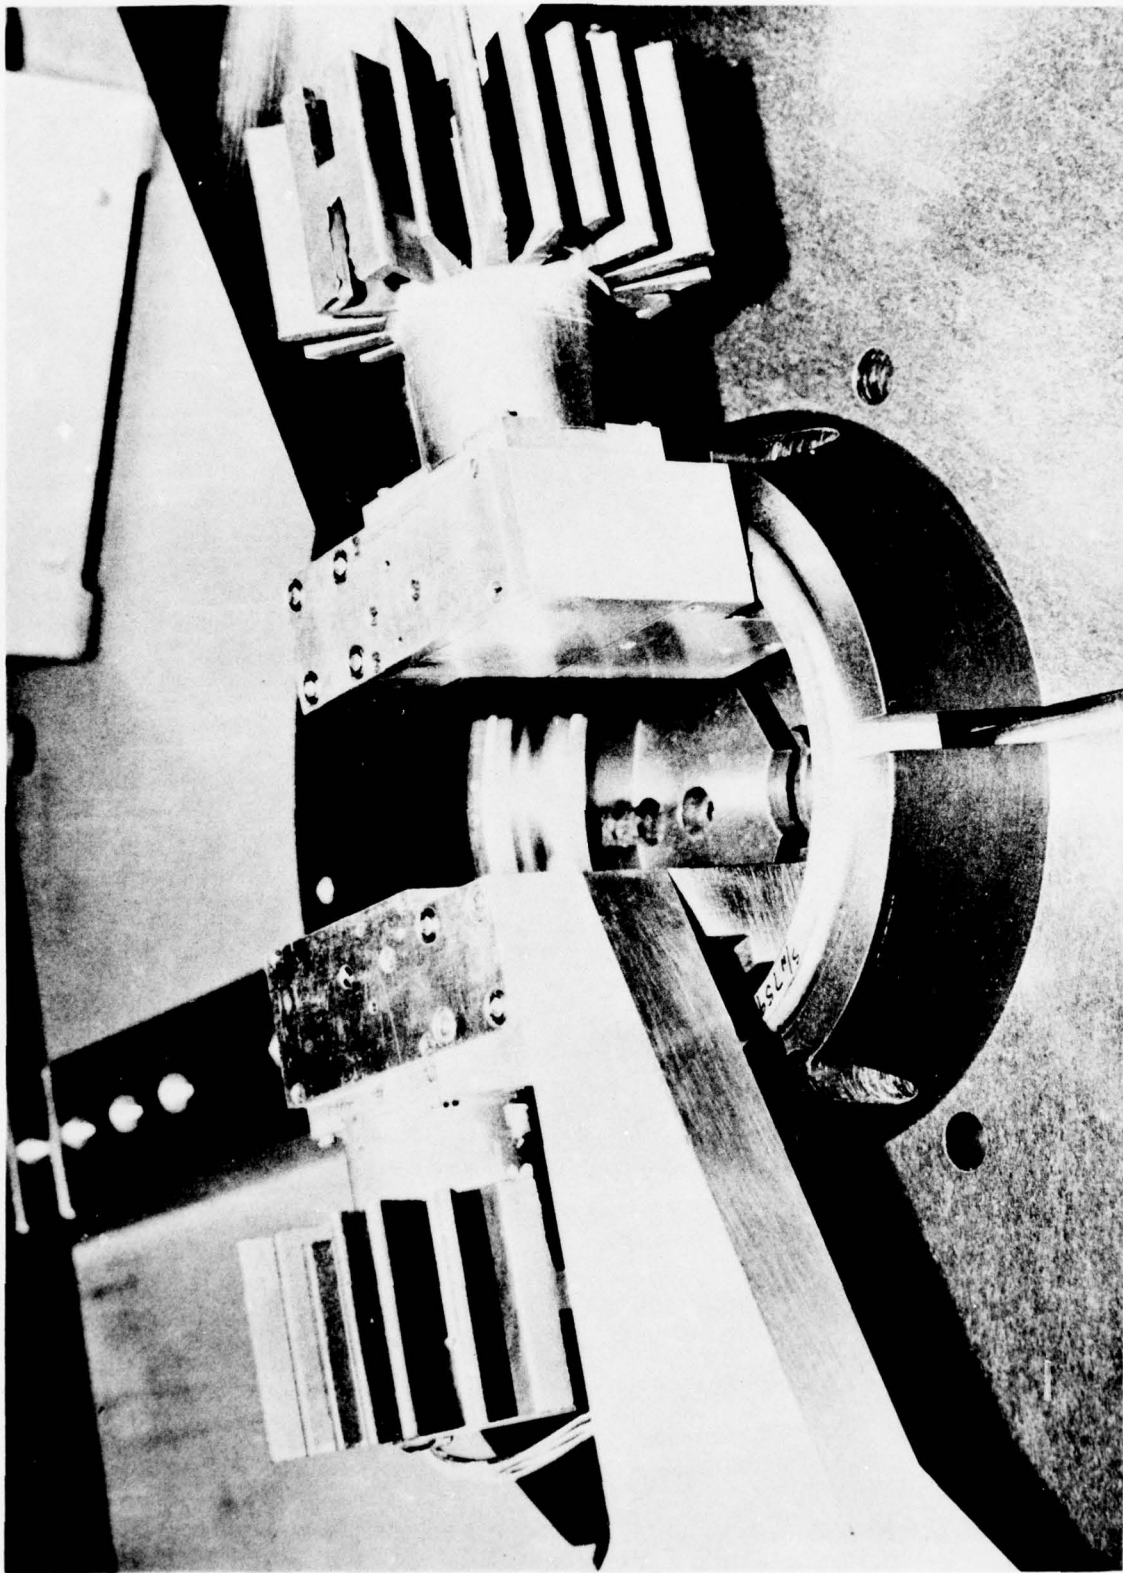
FIGURE A5. CLOSE-UP VIEW OF PROBE MECHANISMS WITHIN OUTER RACE (in position for inspection)

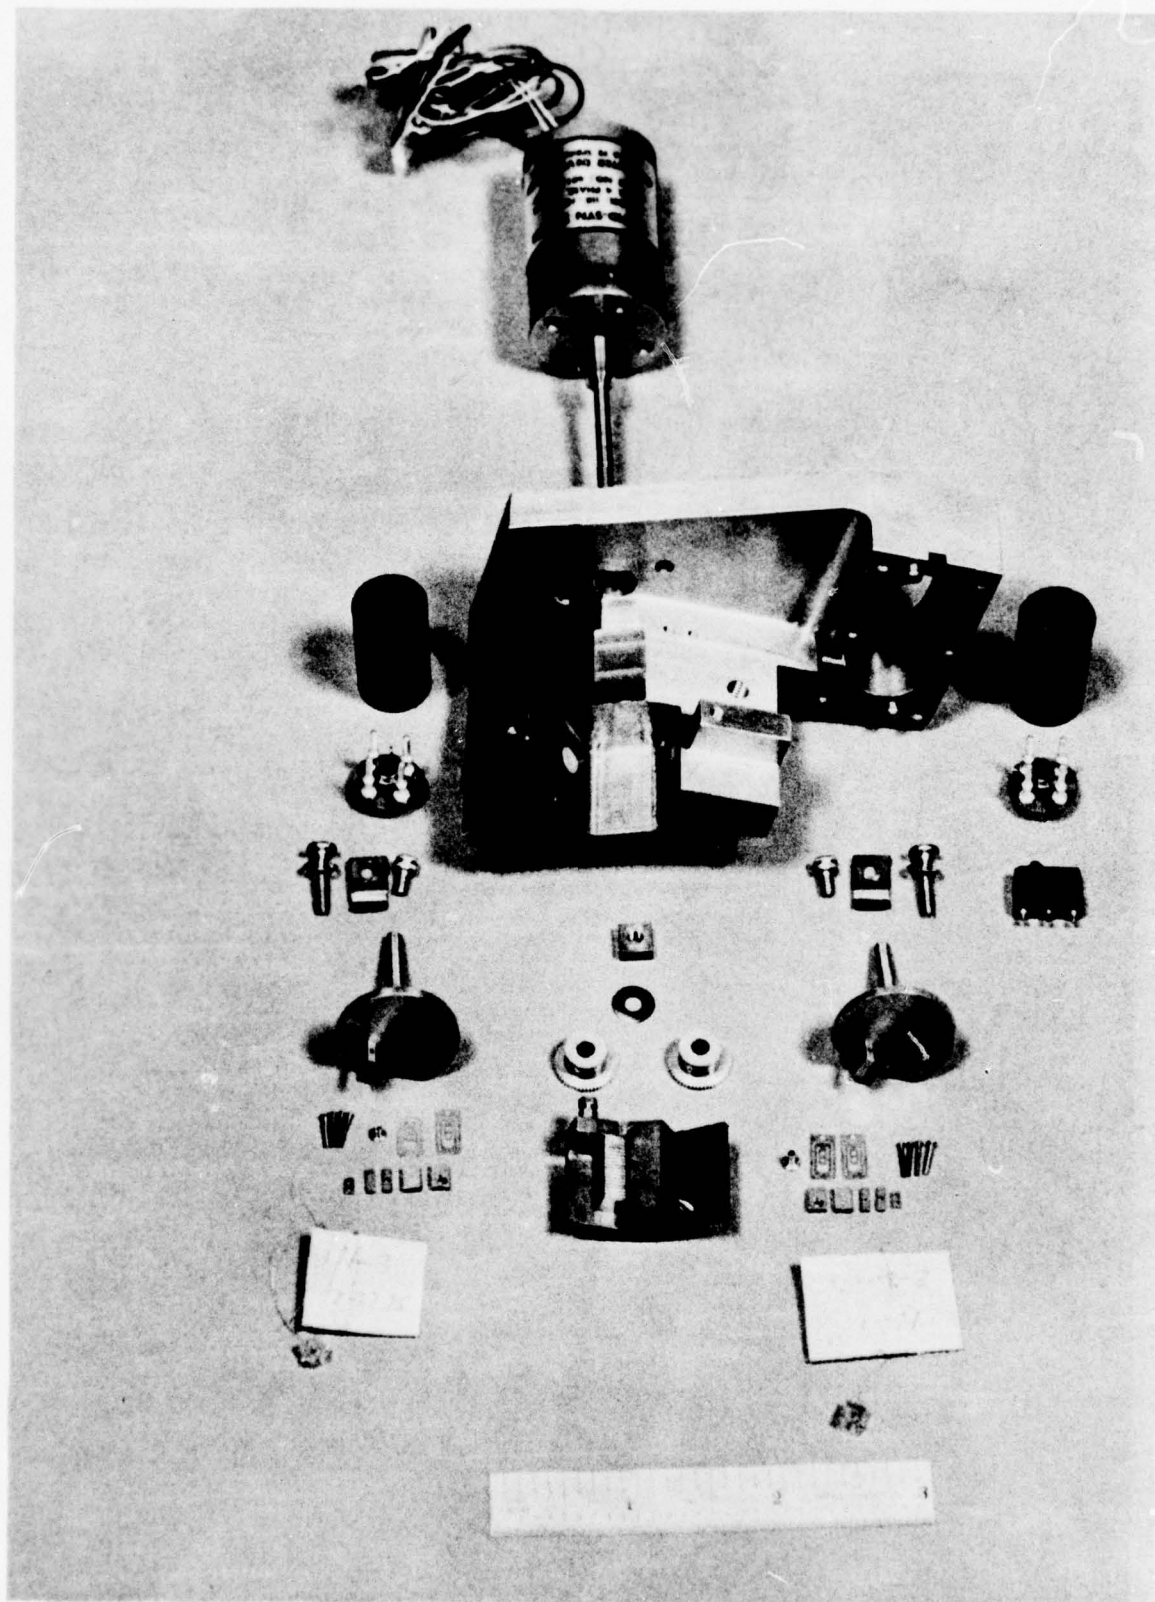
FIGURE A6. VIEW OF TYPICAL SET OF PARTS FOR A MAGNETIC PERTURBATION CIRCUMFERENTIAL RADIAL PROBE MECHANISM

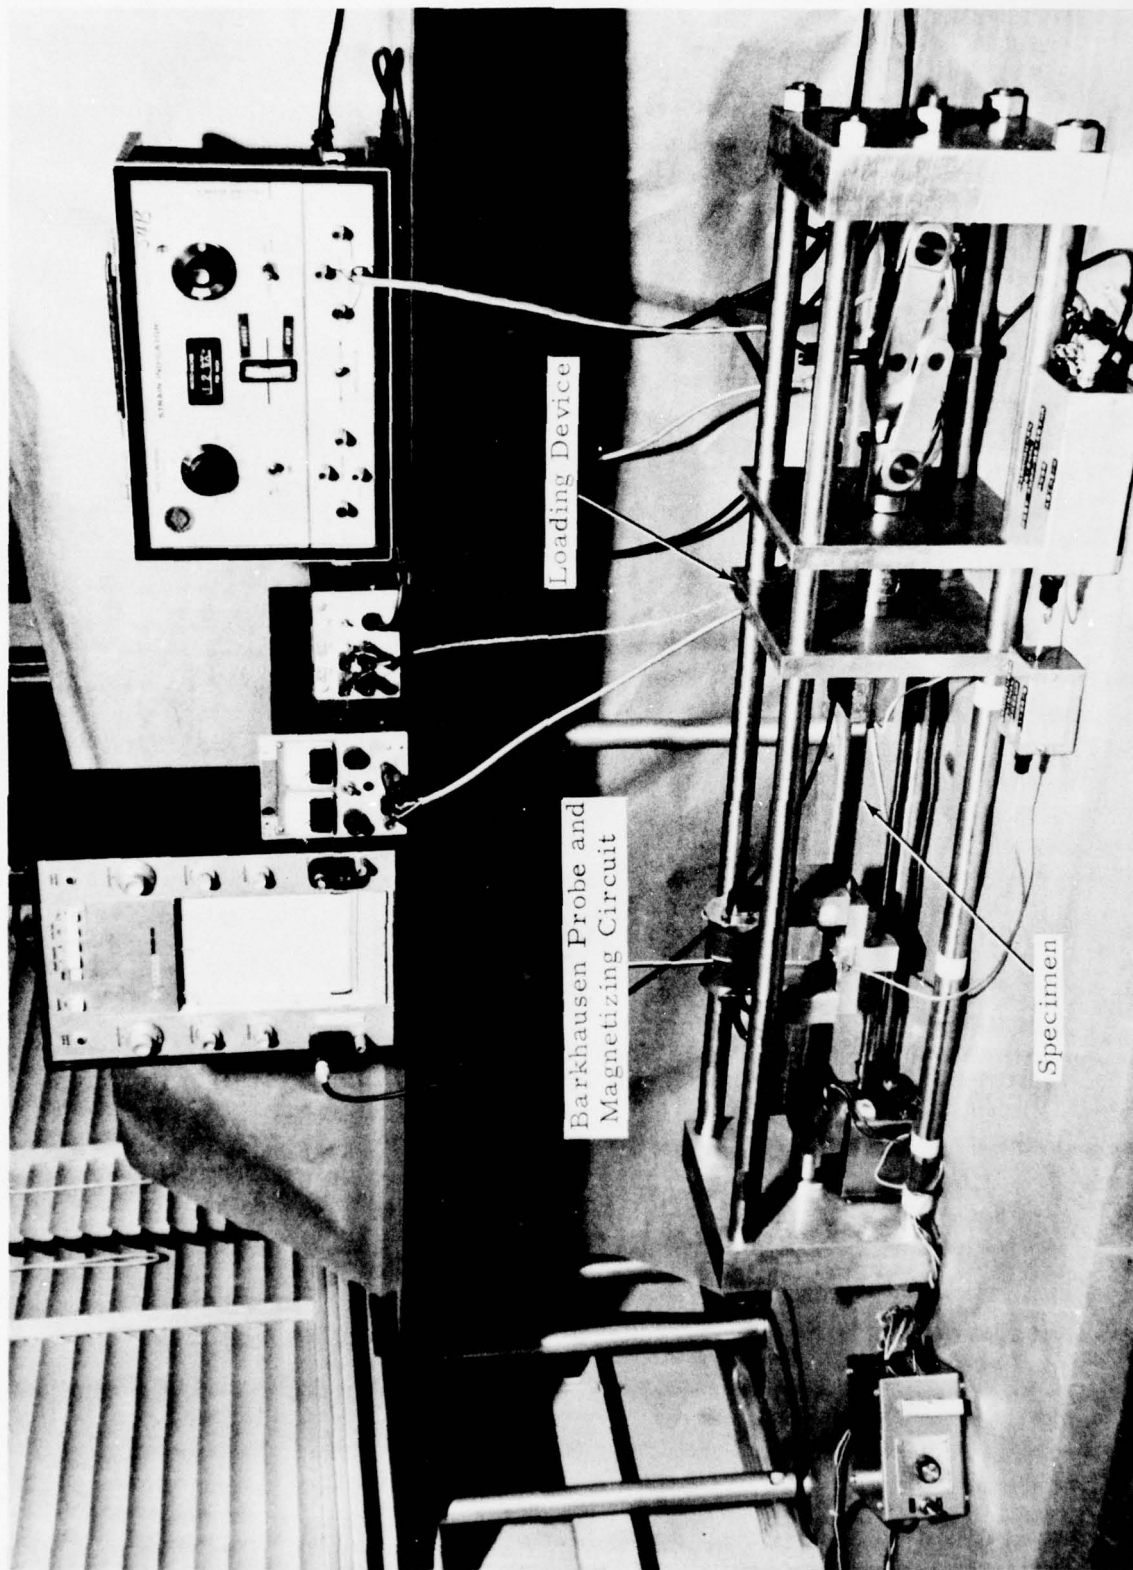
FIGURE A7. CONTINUOUS BARKHAUSEN APPARATUS AND STRESSING FIXTURE FOR FLAT SPECIMEN

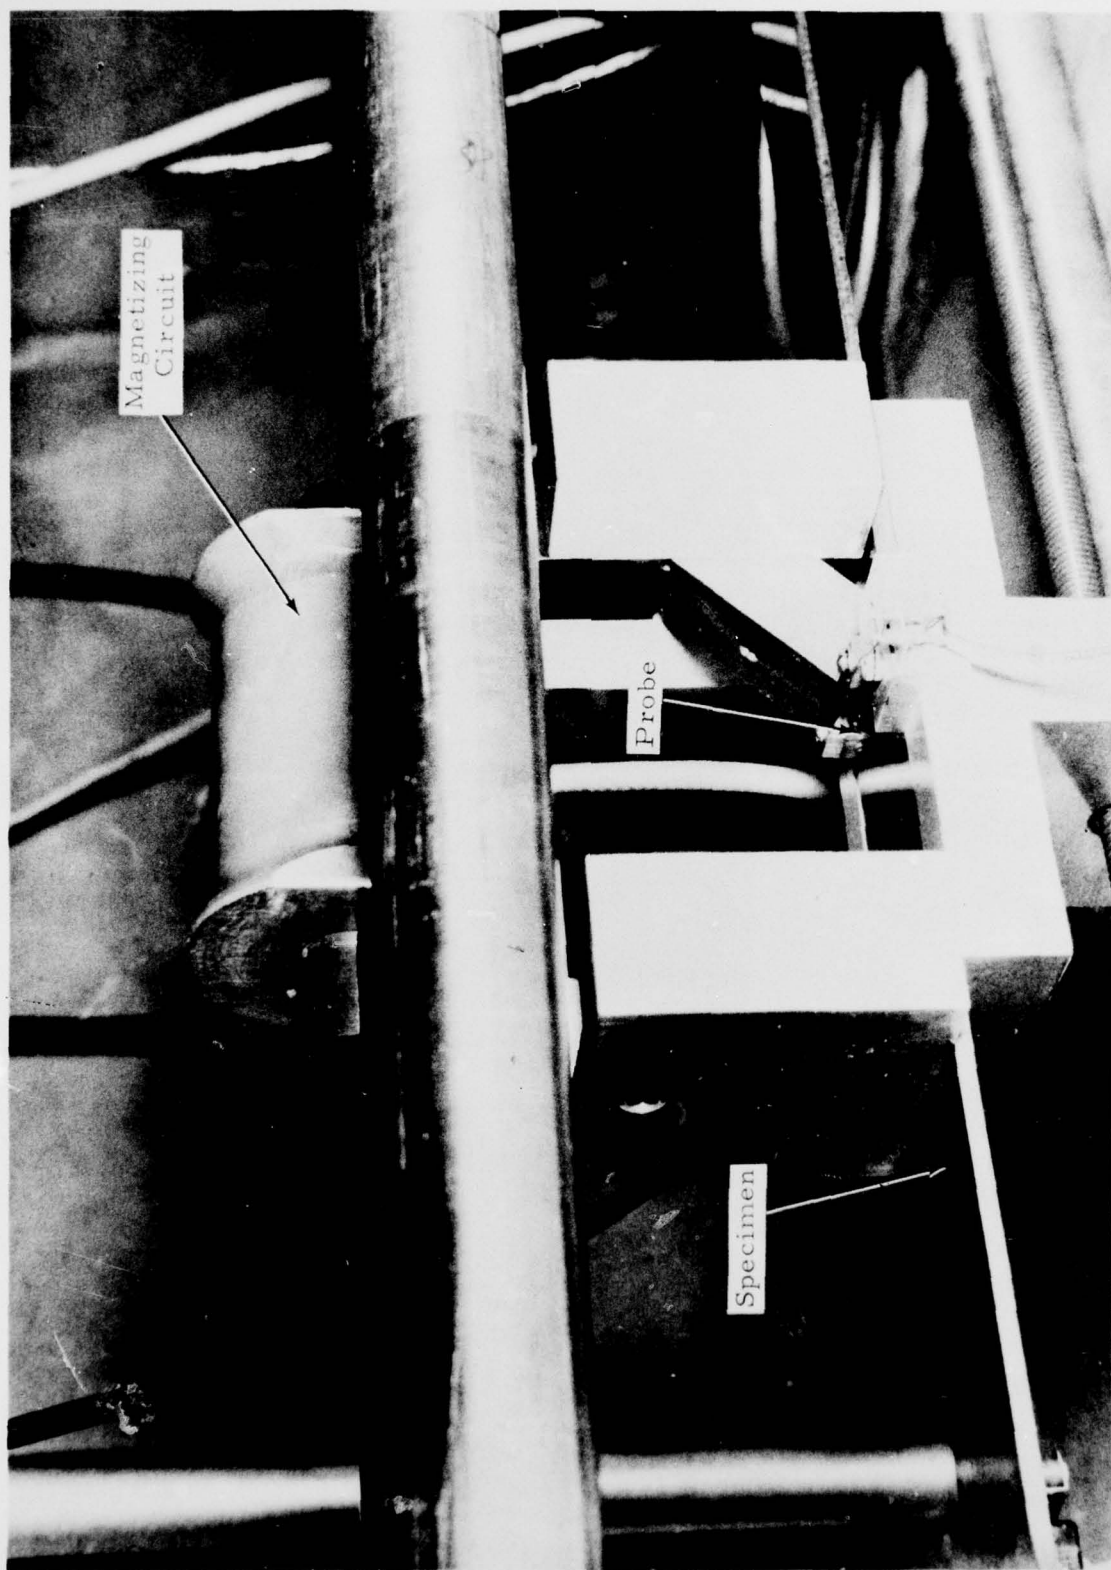
FIGURE A8. CONTINUOUS BARKHAUSEN PROBE, MAGNETIZATION APPARATUS, AND CARRIER ASSEMBLY

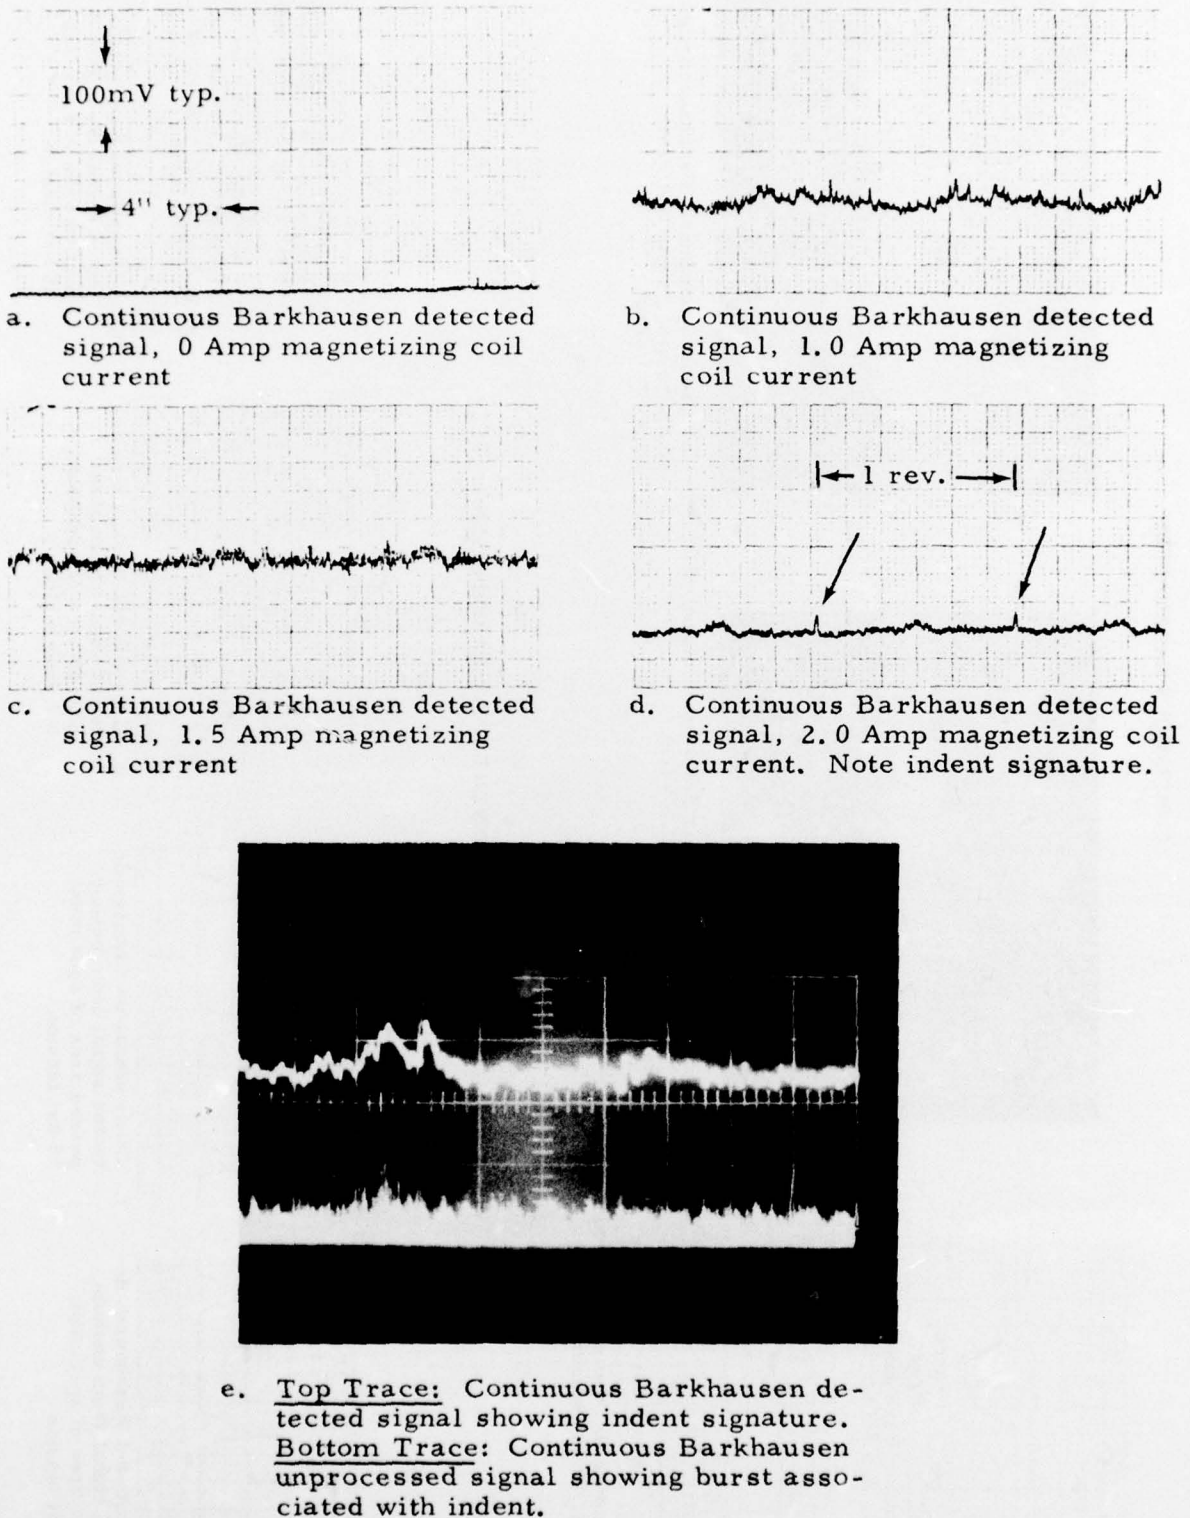
FIGURE A11. CONTINUOUS BARKHAUSEN DATA FROM A ROLLER BEARING RACE

The results obtained from a T53 engine main shaft roller bearing (reject) inner race containing a hardness indentation is shown in Figure A11. Photographs showing the laboratory setup and specimens are presented in Figures A12 and A13. It was found that continuous Barkhausen increased, monotonically, with rotational speed over the range investigated (approximate 1-7 ips surface speed). Records a through d illustrate that as the magnetizing current is increased, the

level of continuous Barkhausen increases to a maximum and then decreases with further increases in magnetizing current; a similar behavior with magnetizing current was noted (but not illustrated) for the annealed 4130 steel flat specimen. In the case of the roller bearing race, when a magnetizing current exceeding that for maximum continuous Barkhausen amplitude was applied, a "pit-type" signal (pointed out by the arrow in Figure A11d) on top of the continuous Barkhausen was noted which was found to correlate with the manufactured indent. Investigations were carried out to verify that the indent signal was a Barkhausen noise signal and not a magnetic perturbation type indication. Record e in Figure A11 shows both the processed and unprocessed Barkhausen signal from the surrounding material, via Barkhausen signal, is significant since it offers the future possibility of a critical appraisal of indentation and brinelling in bearing races.
